Structural Health Monitoring of a Bonded Composite Patch Repair on a Fatigue-Cracked F-111C Wing

DSTO-RR-0335

In 1994 a large (48 mm) fatigue crack was discovered in the wing skin A15-5 of an Australian Defence Force F-111C aircraft, following the investigation of a fuel leak. A decision was made to repair the crack using an adhesively bonded boron/epoxy fibre composite patch. This decision was based on the availability of crack-patching technology, pioneered and developed by DSTO.

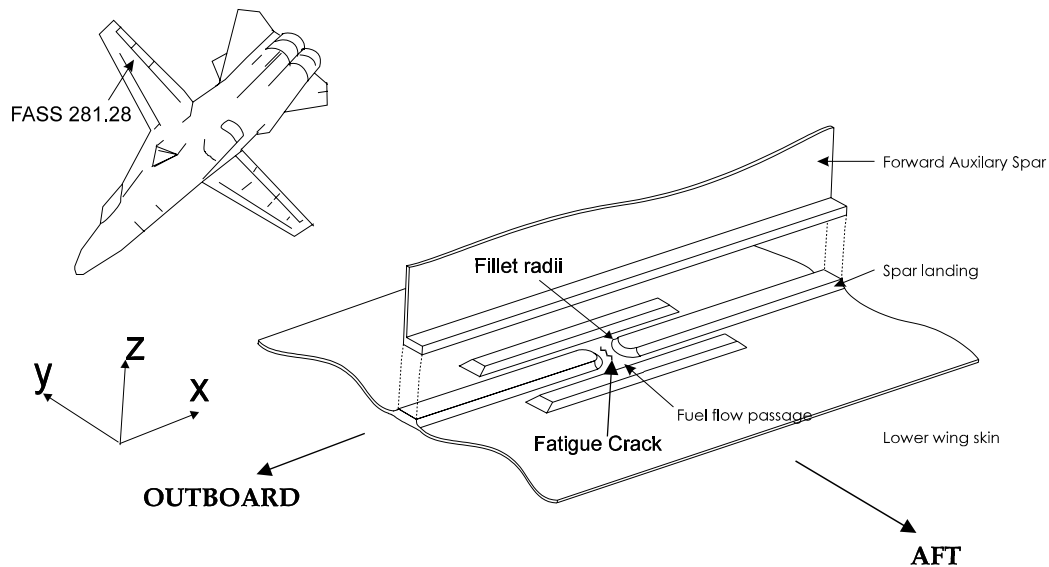
The first visual indication of the crack was fuel seepage around the crack site. A more detailed follow-up NDI inspection of this region revealed a through-thickness crack, 48 mm long tip-to-tip.

Figure 1 indicates the location of cracking on the lower wing-skin. The cracking occurred in an area lying below the forward auxiliary spar at FASS 281.28, where the thickness of the integral stiffener is reduced from approximately 8 mm to the nominal skin thickness (at this location) of approximately 4 mm. The purpose of this depression in the stiffener is to allow full fuel flow and drainage between adjacent bays of the wing-box fuel tank. Two side-stiffeners are intended to compensate for the loss of spanwise stiffness due to this fuel-flow passage, as indicated in Figure 2. These geometrical features lead to a significant stress concentration factor and to out-of-plane or secondary bending at the location of cracking, as discussed in Reference [5].

Figure 1 Location of cracking on the F-111 lower wing-skin, at FASS 281

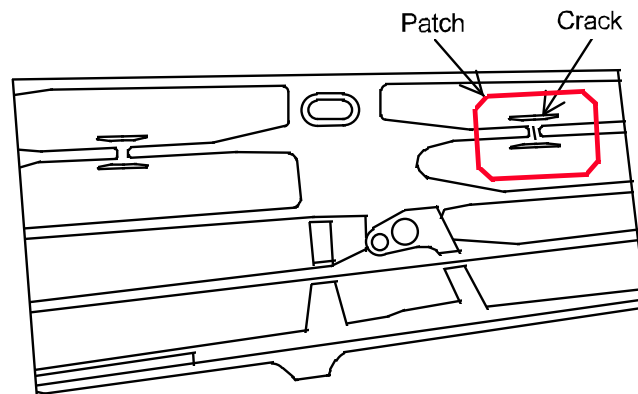
Figure 3: Location of cracking on the F-111 lower wing-skin, at FASS 281, showing the outline of the repair patch on the outside surface, which is made of 14 ply boron/epoxy $(0_2, \pm 45, 0_3)$ size 500 mm spanwise \times 350 mm chordwise.

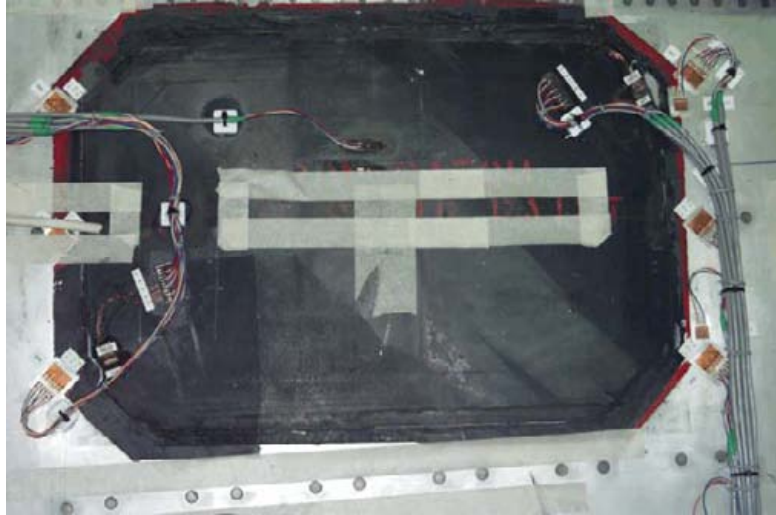
Figure 4: Boron/epoxy patch bonded to F-111 wing skin showing also some of the SHM strain gauges used during the fatigue test to check for patch disbonding.

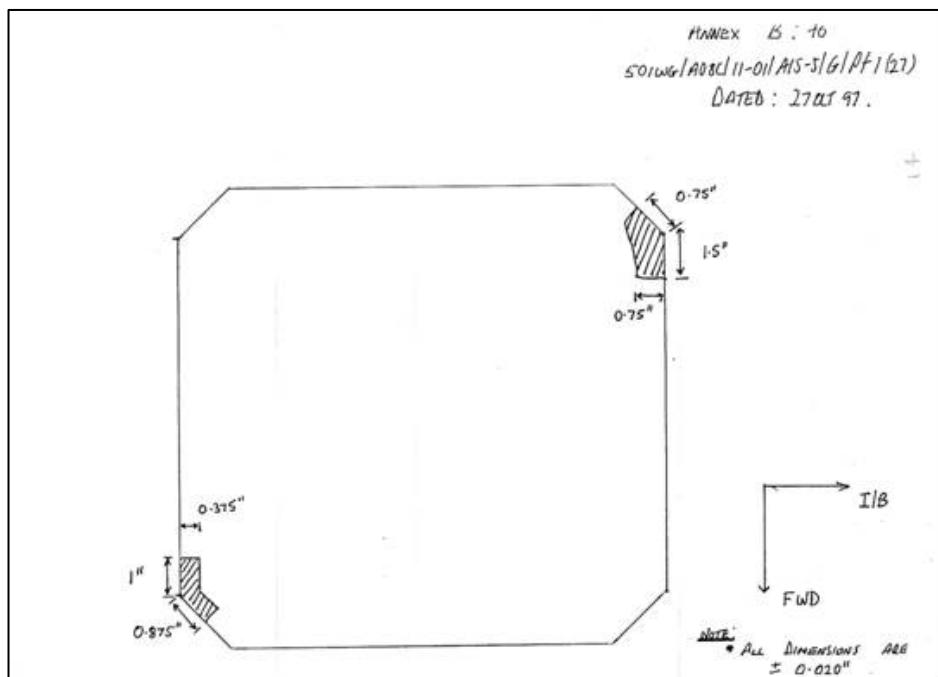
The disbond history of the patch during service was somewhat more difficult to interpret. There is a report of the presence of disbands in the patch system after application at 4749.5 flying hours; however, the disbands reported were very small (less than 3mm diameter) and generally not in the regions where the disbands were detected later. No further disbands were found until at 5417.7 flying hours when clearer and more credible indications of disbands were obtained, as indicated in Figure 8, which shows relatively small disbands at the patch corners.

Figure 8 Sketch of disbands detected by RAAF inspection at 5607 hours, just prior to retiring of wing for the fatigue test

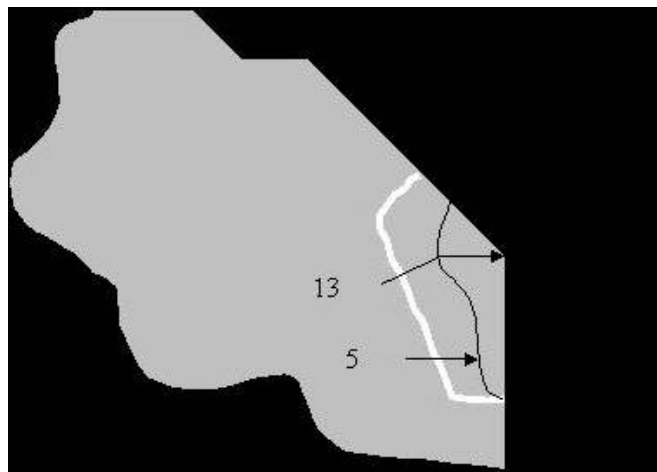
The wing was then transferred to DSTO for inspection prior to the fatigue test. Using a Novascope 4000 (not then available to RAAF) one of the disbond areas was reinspected with the result shown in Figure 9. This inspection confirmed the presence of one of the disbonds noted by RAAF but shows it to be significantly smaller than indicated in the RAAF report.

Figure 9: Sketch of the disbond region, top right Figure 8, showing in white outline the disbond area noted by RAAF and in black line the region noted at DSTO using a Novascope 4000 pulse echo instrument

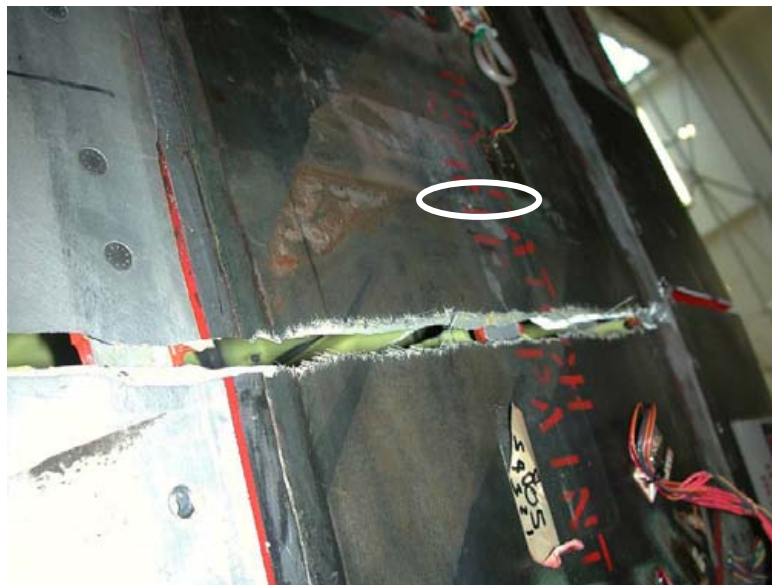
The crack passed through the aircraft wing skin and boron/epoxy patch in a region well away from the repaired crack, Figure 10.

Figure 10 Boron patch after failure of the wing. The white ellipse shows the approximate position of the patched crack.

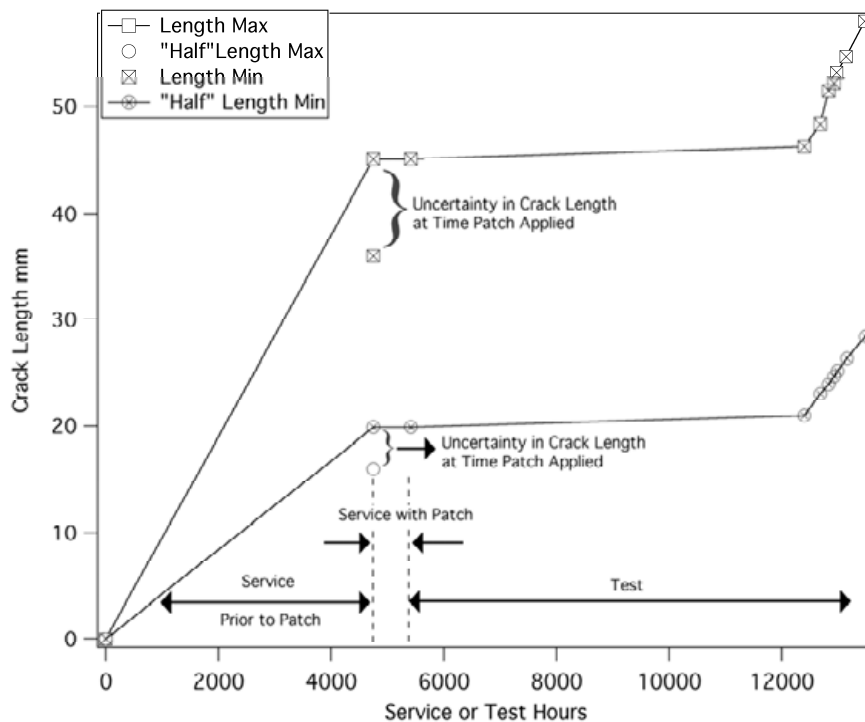
Figure 11 Plot of crack size over the life of the wing measured from fractographic analysis of the patched crack region, derived from Appendix 1

The fractographic observations indicate that the initial full length of the crack was between 36 mm (min) to 45.1 mm (max) with zero to negligible growth up to around 12000 hours. There was considerable uncertainty from the fractographic study at this stage, presumably because of the state of the fracture surface. Then from 12400 hours to 13507 hours the crack propagated to a length of 58 mm at which time final wing failure occurred.

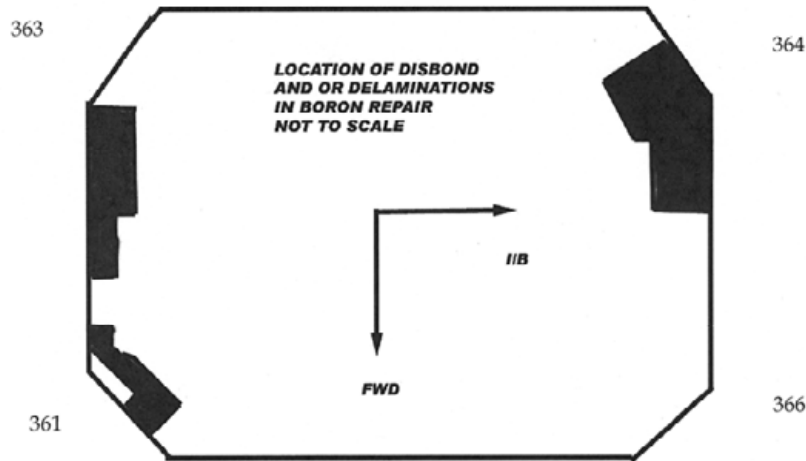
Figure 12 Sketch of disbond distribution detected during the fatigue test at 10525 hours, corresponding to approximately Block 10; also shown as locators are the approximate positions used for the skin strain gauges.

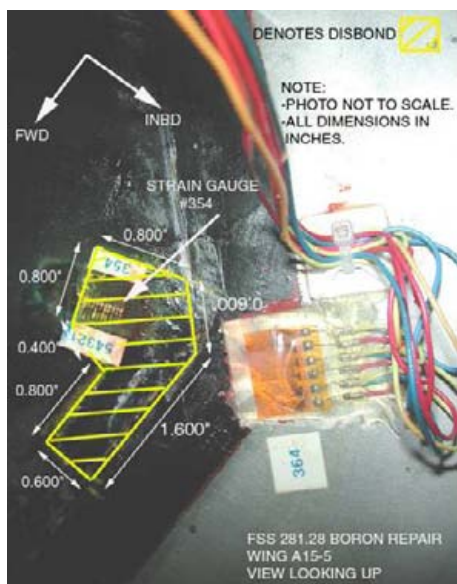
Figure 13: NDI indications of disbonds at 10572 SFH ~ Block 10 in the region of skin gauge 364 and patch gauge 354. Later at Block 12 strip gauges 356 and 357 and single gauge 803 were

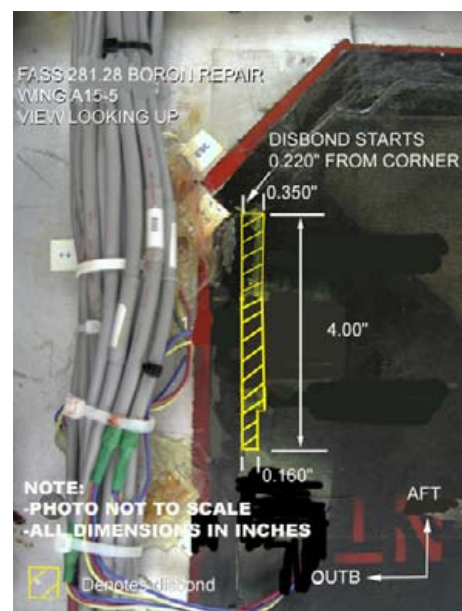
Figure 14: NDI indications of disbonds between the patch and substrate material at 10572 SFH, Block 10 in the region between skin gauges 363 and 361. Later at Block 12 patch gauges 802

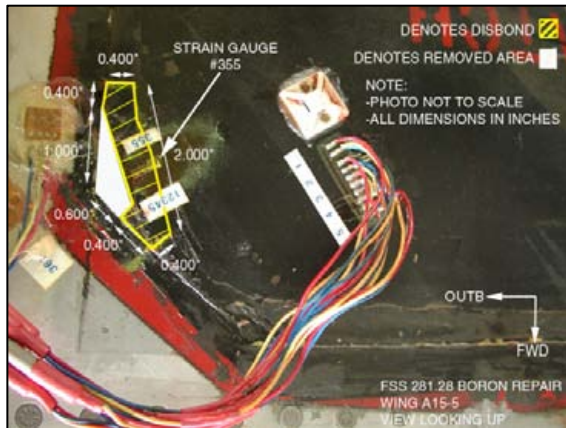
Figure 15: NDI indications of disbonds between the patch and substrate material at 10572 SFH Block 10 in the region of skin gauge 361 and patch gauge 355. Later, at Block 12 patch strip gauges 358 and 359 were applied in this region

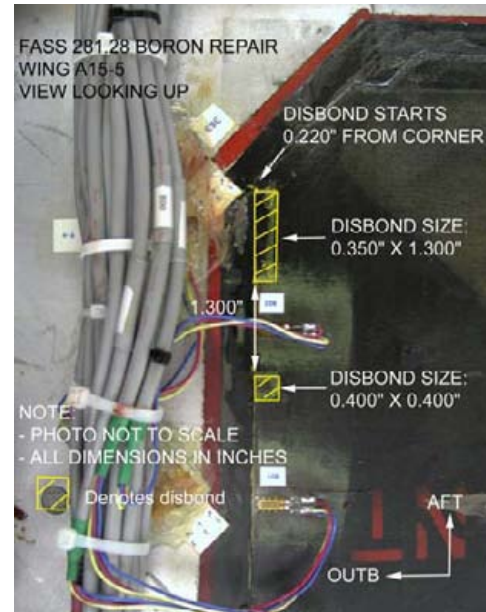
Figure 16: NDI indications of disbonds between the patch and substrate material at 11082 SFH ~ Block 11 in the region of skin gauges 363 and 361. Later at Block 12 patch gauges 802, 800 and 805a were bonded to this region

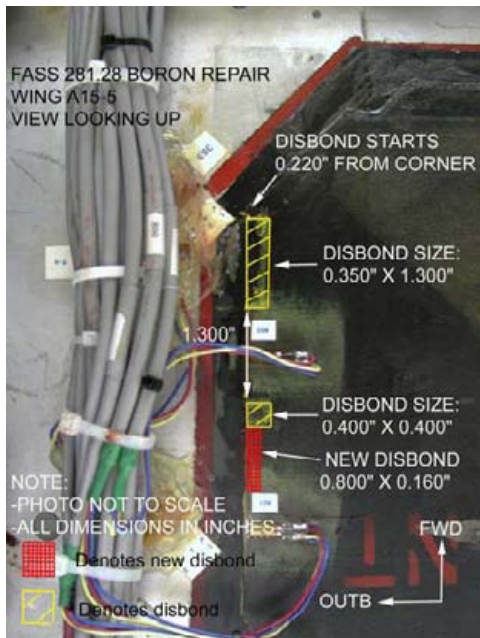
Figure 17: NDI indications of disbonds between the patch and substrate material at 11500 SFH Block 12 in the region skin gauges 363 and 361. Later patch gauges 802, 800 and 805a were bonded to this region.

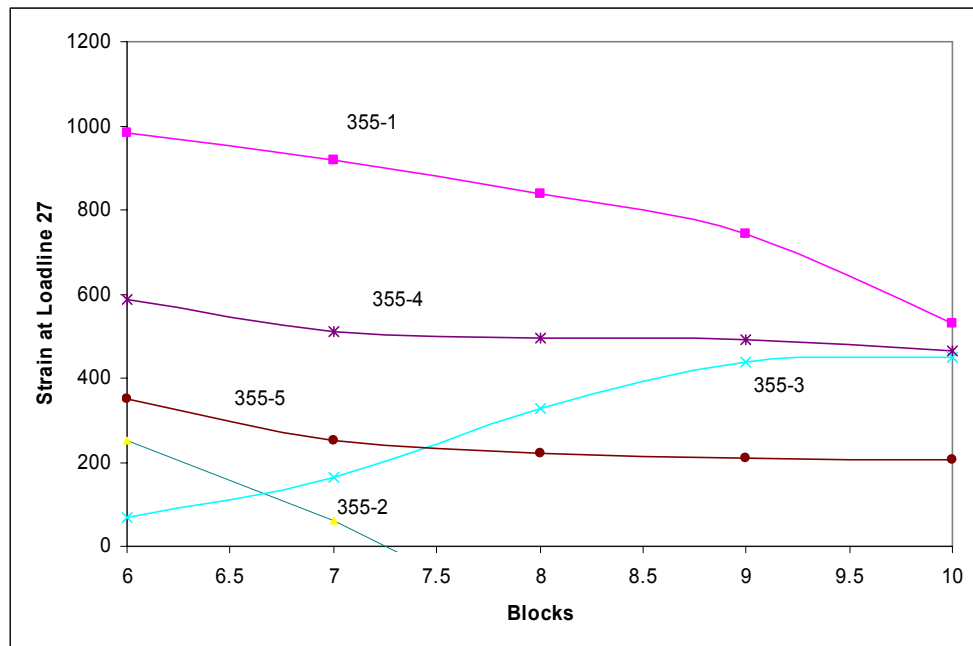
Results for strip-gauge 355-1, 4 and 5, provided in Figure 25 indicate a gradual growth of the pre-existing disbonds; gauges 355-2 and 355-3 exhibit anomalous behaviour. Figure 15 shows the corresponding NDI indications in this region at Block 10.

Figure 25: Strain versus block number for strip-gauge 355 for Blocks 6 to 10; the skin gauge location is 361 and the patch gauge positions are as indicated in Figure 20

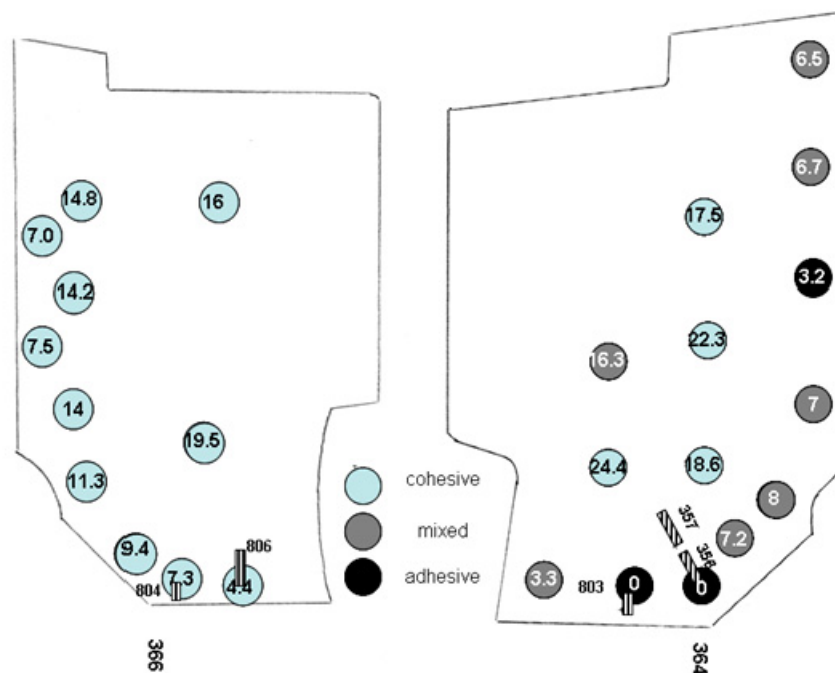
Figure 34: Patch segments showing the bond test results. The location of the bond test plugs are shown together with the bond strength in MPa and failure mode. The locations of strain gauge strips and single gauges are also shown. The mixed or adhesive modes refer respectively to part or complete separation at the aluminium alloy surface.

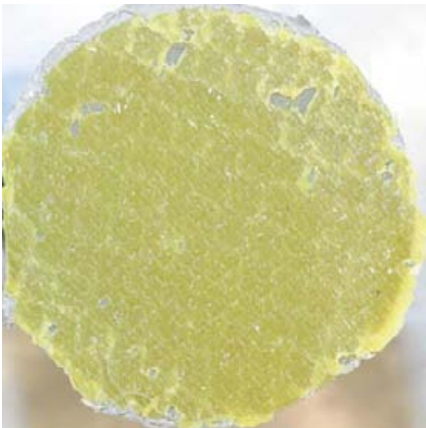
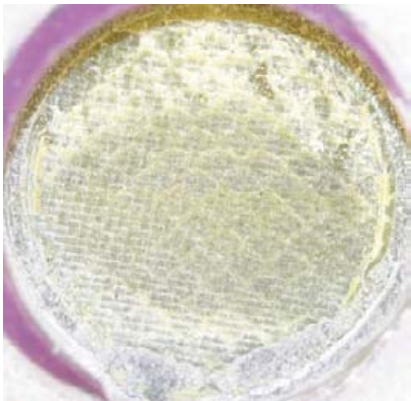
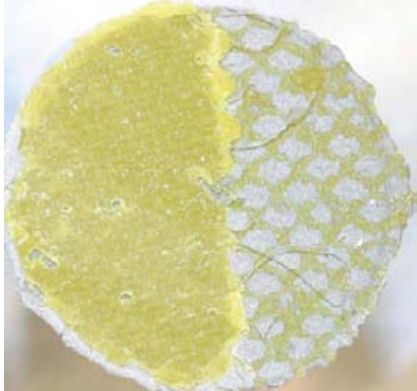
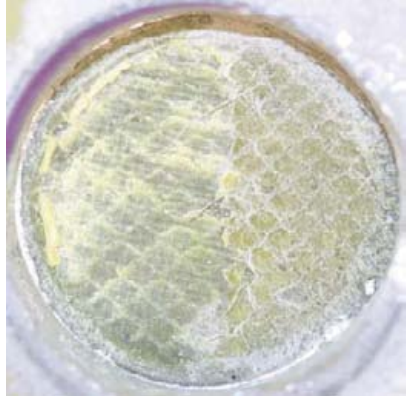
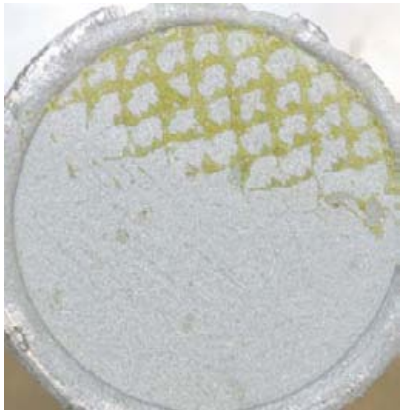
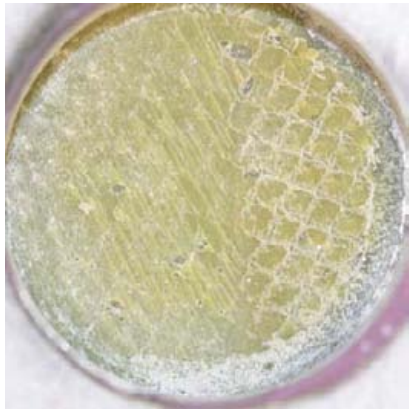
Figure 35 Photographs of fracture surfaces produced by the bond test, showing the main failure modes, as indicated

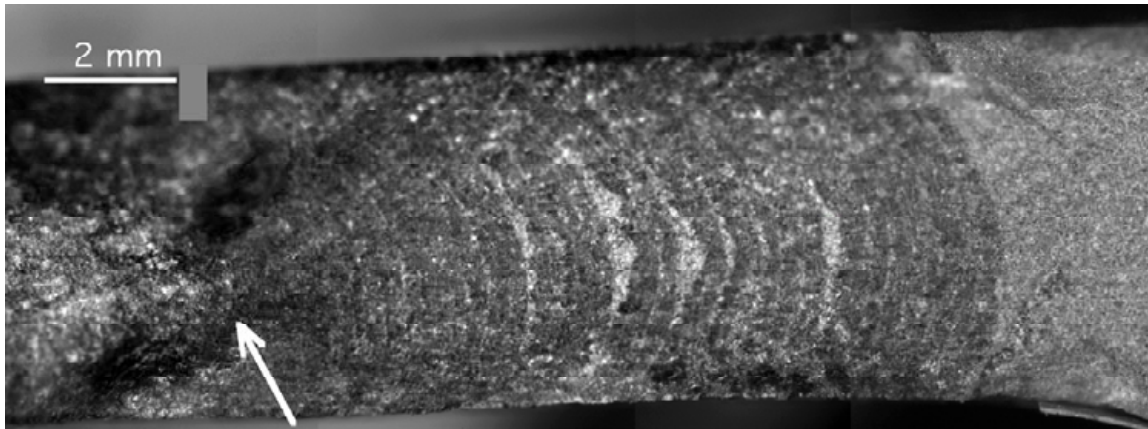
Close examination of one end of the cracking (to the right in Figure A1) revealed a series of tear bands (Figure A2), but no obvious repeating pattern was evident.

Figure A2. Detail of the end of fatigue cracking in the crack under the patch. Note that this fractograph was produced using crossed polarised illumination, which depicts tensile tearing as light bands and fatigue fracture by striation formation dark. Note the arrow, which indicates the rubbed region from which the final cracking appears to have developed.

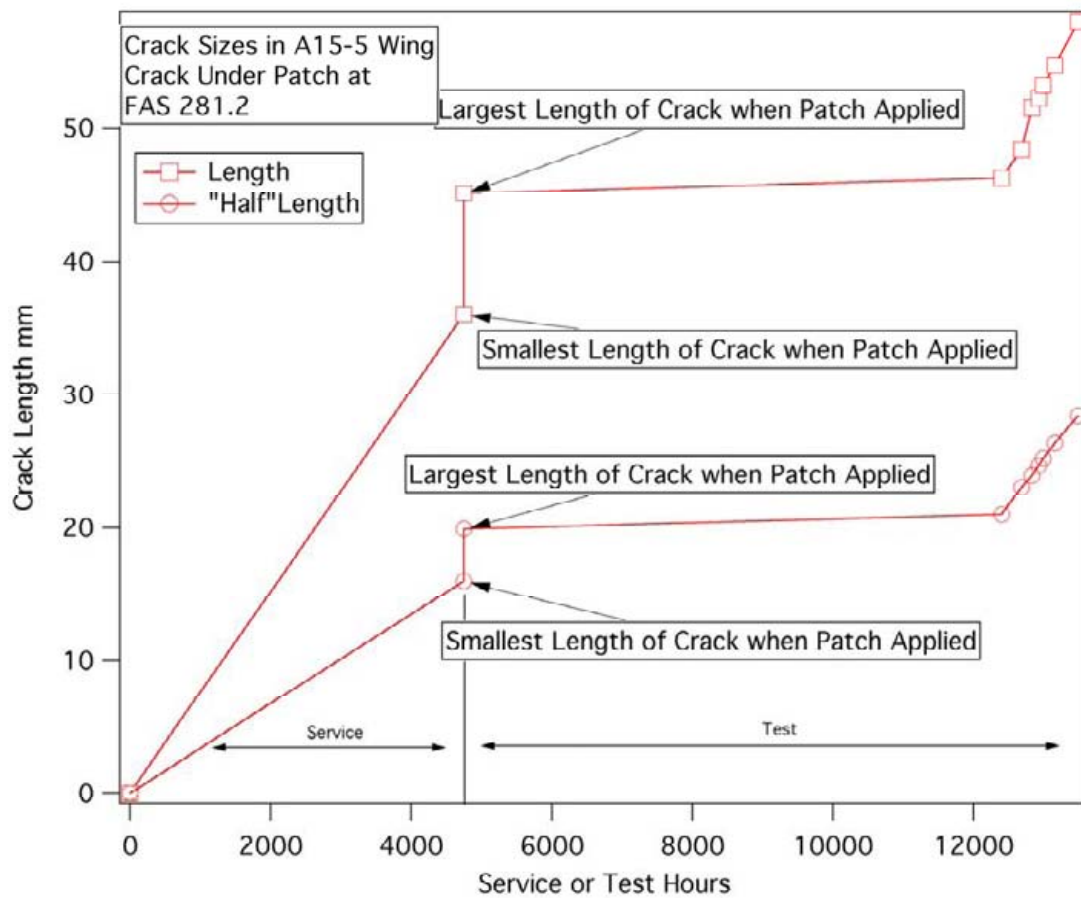
Figure A3. Plot of growth of crack at FAS 281. The growth of the "Half" crack length and the total crack length are plotted. Note that the initial defect is a notional size for the purpose of demonstrating the overall changes in crack growth rate in a simple way.
